PORTER SUBDIVISION  
WATERMAIN REPLACEMENT AND ROAD  
RECONSTRUCTION, DORCHESTER, ON

PROJECT No.  
**DEL20-003A**

SHEET No.  
**41**

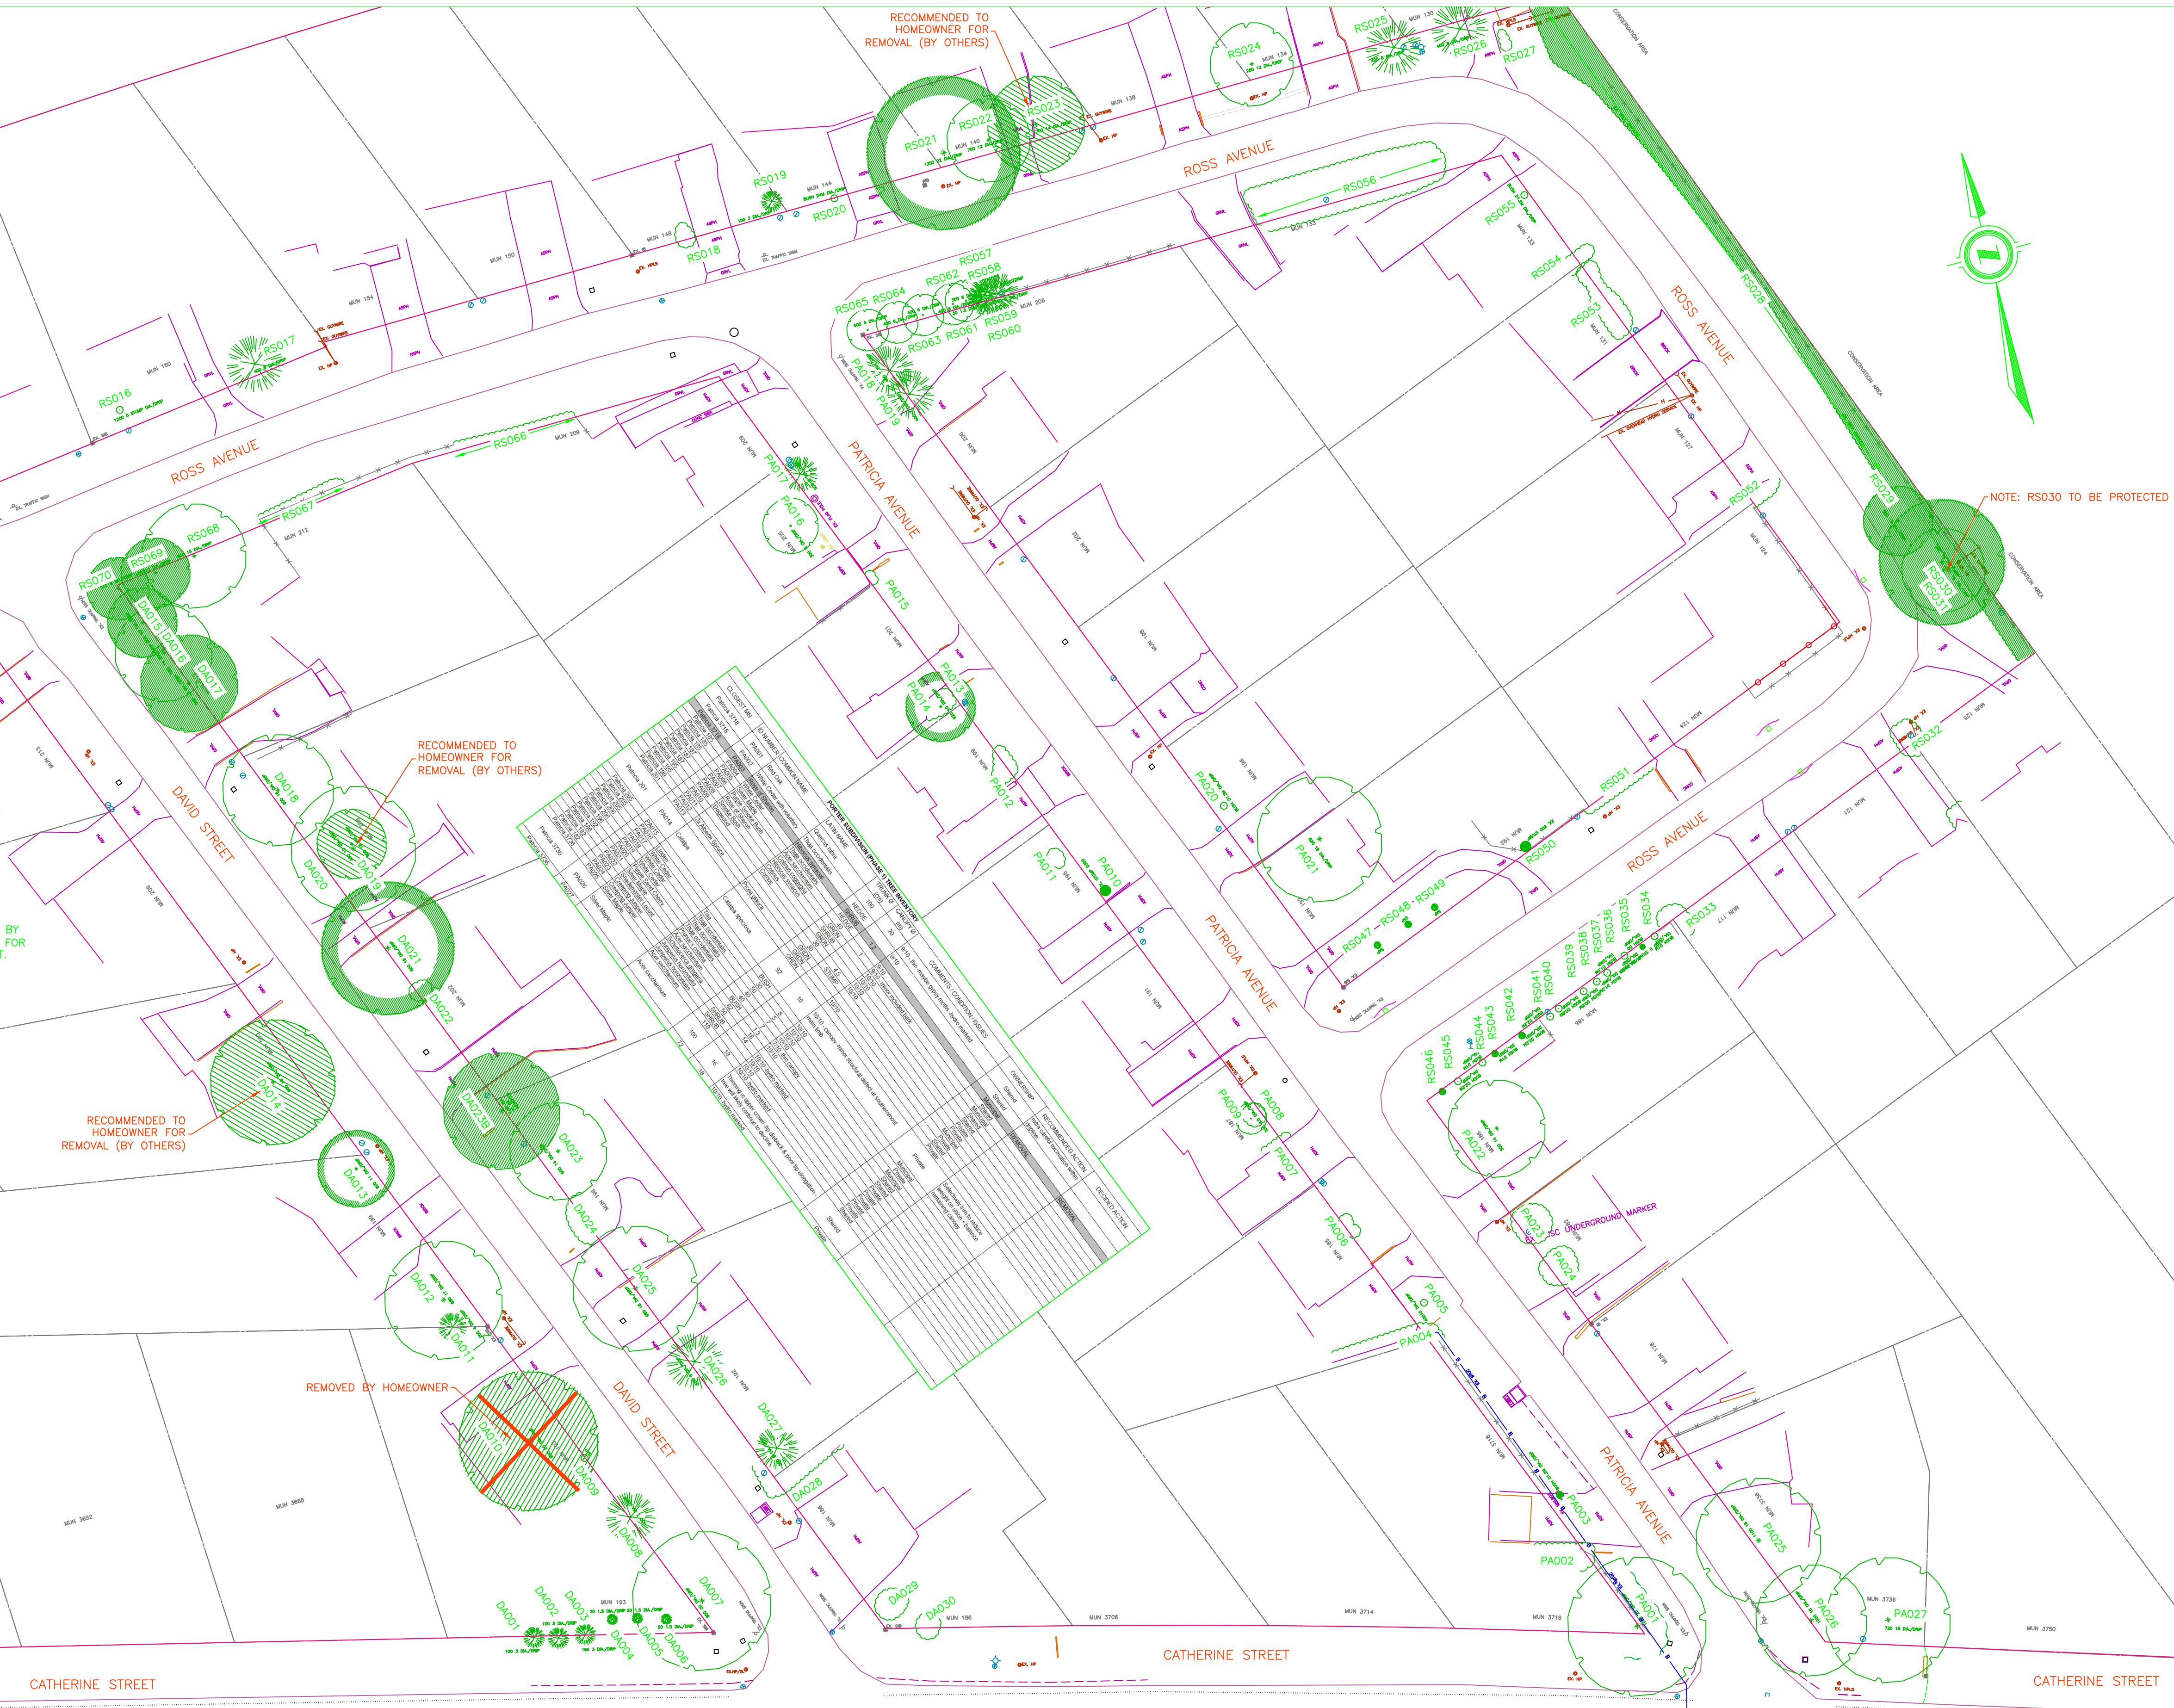
CLOSEST MN	COMMON NAME	LATIN NAME	DBH (CM)	CANOPY H (M)	COMMENTS / CONDITION / ISSUES	OWNERSHIP	RECOMMENDED ACTION	DECIDED ACTION
Ross 130	Silver Maple	<i>Acer saccharinum</i>	120	22	10/10 - canopy marked for hydro-timing - scanned crown active - multiple dominant stems - included bark at main trunk - canopy well developed - several leaders at risk of failure	Private	pruning to remove or reduce risk - multiple dominant stems - include bark at main trunk - canopy well developed - several leaders at risk of failure	
Ross 140	Silver Maple	<i>Acer saccharinum</i>	70	12	10/10 - canopy health - marked for hydro - scanned roots from ground - canopy well developed - several leaders at risk of failure	Private	pruning to remove or reduce risk - multiple dominant stems - include bark at main trunk - canopy well developed - several leaders at risk of failure	
Ross 140	Silver Maple	<i>Acer saccharinum</i>	70	14	marked for hydro - on dominant stem - 2 decaying areas at main union with fungal fruiting bodies present	Private	RECOMMEND REMOVAL TO HOMEOWNER	removed by others

Ross 134	Shadblow Locust	<i>Schistoceca pinnata</i>	28	12	10/10 - canopy health - marked for hydro - Bell Rogers & Hydro service tagged throughout canopy	Private		
Ross 134	White Cedar	<i>Thuja occidentalis</i>	40	8	10/10 - canopy health - marked for hydro - multi stemmed with little structural defects present	Municipal		
Ross 130	White Cedar	<i>Thuja occidentalis</i>	40	8	10/10 - canopy health - marked for hydro	Municipal		
Ross 130	White Cedar	<i>Thuja occidentalis</i>	40	8	10/10 - canopy health - marked for hydro	Municipal		
Ross 130	White Cedar	<i>Thuja occidentalis</i>	40	8	10/10 - canopy health - marked for hydro	Municipal		
Conservation Area	Tree line comprised of Sugar Maple, American Hornbeam, Red Spruce, Black Cherry & multiple dead Ash	various			10/10 - general forest health	Municipal	at dead Ash within striking distance of road - risk to road - location should be marked with caution - RTU or equivalent	Removal as noted

Conservation Area	Ash	<i>Fraxinus</i>	35	10	DEAD	Municipal	REMOVAL	REMOVAL
Conservation Area	Sugar Maple	<i>Acer saccharinum</i>	95	18	Sugar Maple with major trunk decay - tree poses serious liability to public & structure	Municipal	REMOVAL	REMOVAL
Ross 130	Black Cedar	<i>Thuja occidentalis</i>	40	8	10/10	Shared		
Ross 130	Black Cedar	<i>Thuja occidentalis</i>	40	8	10/10	Shared		
Ross 130	Black Cedar	<i>Thuja occidentalis</i>	40	8	10/10	Shared		
Ross 130	Black Cedar	<i>Thuja occidentalis</i>	40	8	10/10	Shared		
Ross 130	Black Cedar	<i>Thuja occidentalis</i>	40	8	10/10	Shared		
Ross 130	Black Cedar	<i>Thuja occidentalis</i>	40	8	10/10	Shared		
Ross 130	Black Cedar	<i>Thuja occidentalis</i>	40	8	10/10	Shared		
Ross 130	Black Cedar	<i>Thuja occidentalis</i>	40	8	10/10	Shared		
Ross 130	Black Cedar	<i>Thuja occidentalis</i>	40	8	10/10	Shared		
Ross 130	Black Cedar	<i>Thuja occidentalis</i>	40	8	10/10	Shared

Ross 130	Black Cedar	<i>Thuja occidentalis</i>	40	8	10/10	Shared		
Ross 130	Black Cedar	<i>Thuja occidentalis</i>	40	8	10/10	Shared
